“Site Survey Photos” Task in NTP Review

Site Survey Required Photos

NTP Site Survey Requirements

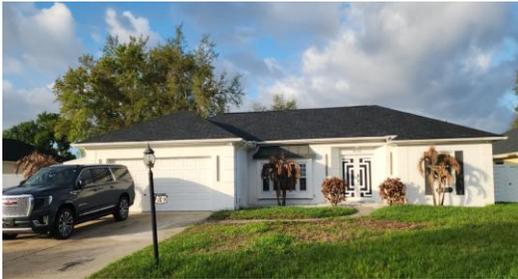
Please ensure that this photo encompasses the entire front of the structure that you intend to install the system on. We should be able to clearly identify any existing system and the condition of the roof.
Structure Overview Information	Right Side of Structure

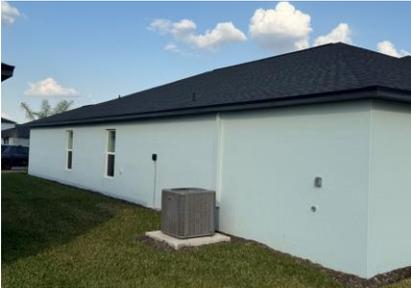
Please ensure that this photo encompasses the entire right side of the structure that you intend to install the system on. We should be able to clearly identify any existing system and the condition of the roof.
Structure Overview Information	Left Side of Structure

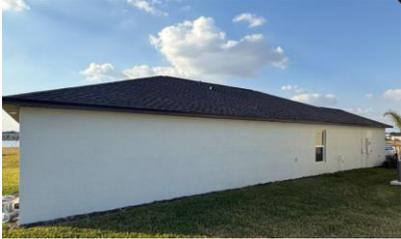
Please ensure that this photo encompasses the entire left side of the structure that you intend to install the system on. We should be able to clearly identify any existing system and the condition of the roof.
Structure Overview Information	Back Side of Structure

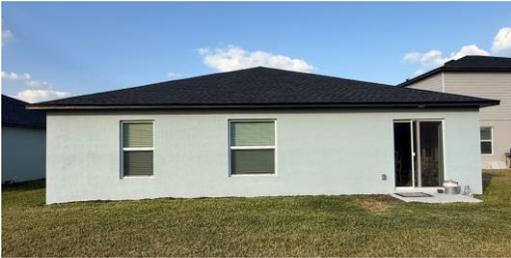
Please ensure that this photo encompasses the entire back side of the structure that you intend to install the system on. We should be able to clearly identify any existing system and the condition of the roof.

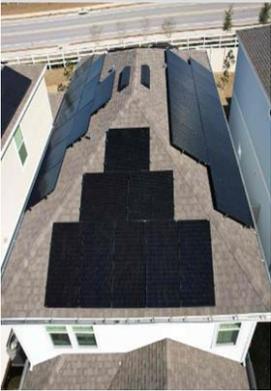
Structure Overview Information	Photo of Roof

Please ensure that this photo encompasses the entire roof not just the section that you intend to install the system on. We should be able to clearly identify any existing system and the condition of the roof.

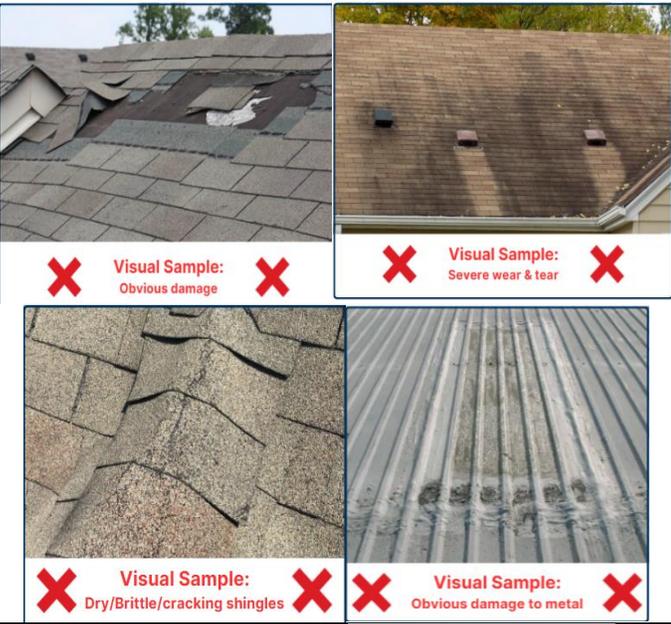
Section	Photos to Capture	Example Image	Notes
	Obvious Damage or Wear & Tear

<p>Visual Sample: Obvious damage</p> <p>Visual Sample: Severe wear & tear</p> <p>Visual Sample: Dry/Brittle/cracking shingles</p> <p>Visual Sample: Obvious damage to metal</p>	
	Compromised Decking

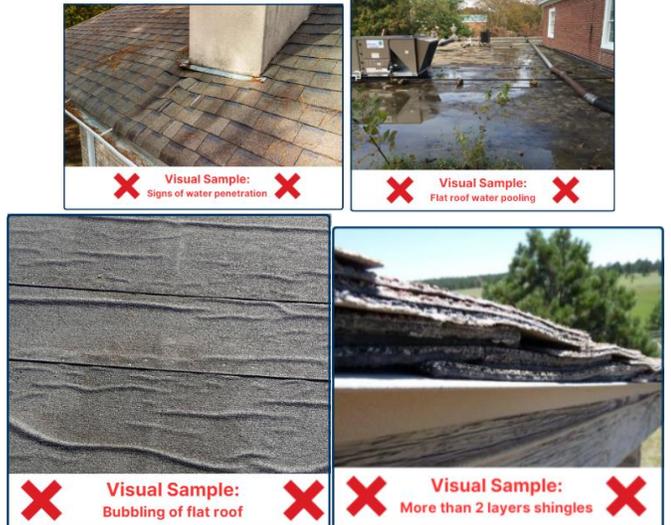
<p>Visual Sample: Signs of water penetration</p> <p>Visual Sample: Flat roof water pooling</p> <p>Visual Sample: Bubbling of flat roof</p> <p>Visual Sample: More than 2 layers shingles</p>	
	Missing Coverage

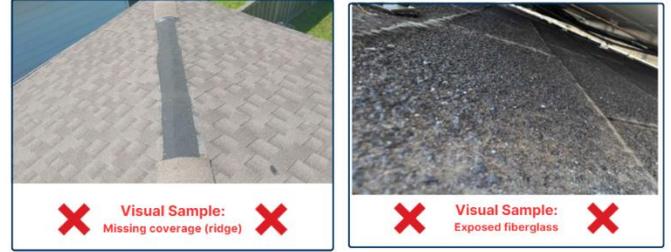
<p>Visual Sample: Missing coverage (ridge)</p> <p>Visual Sample: Exposed fiberglass</p>	
	Unacceptable Structures/Installations Pergolas Carports Custom structures Ground Mounts

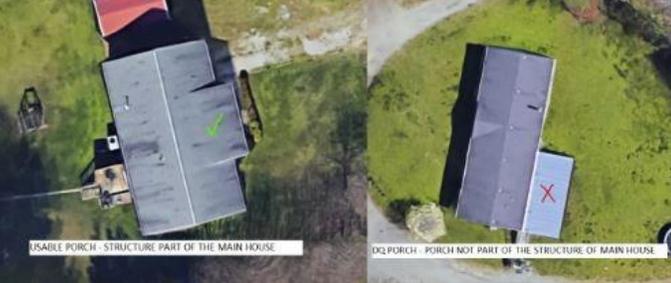
<p>USABLE PORCH - STRUCTURE PART OF THE MAIN HOUSE</p> <p>DQLPORCH - PORCH NOT PART OF THE STRUCTURE OF MAIN HOUSE</p>

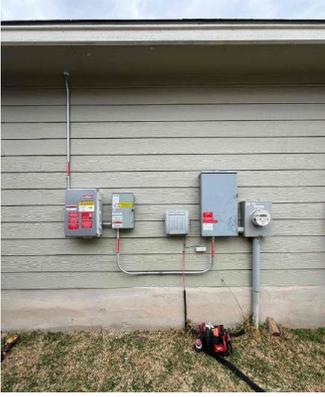
Pulled-back photo to show the entire Electrical Wall including main service panel, inverters, monitoring equipment, disconnects, conduit, meter, etc.
Electrical Documentation	Close-Up of Utility Meter Number

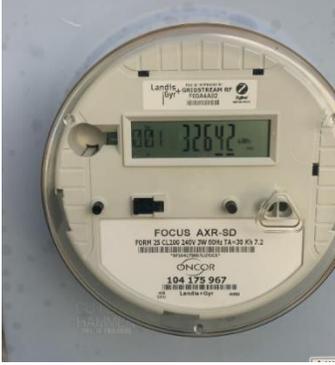
Photo of the meter should show the meter close enough to see the labeling and printing on the meter's face.
Electrical Documentation	Main Breaker Rating

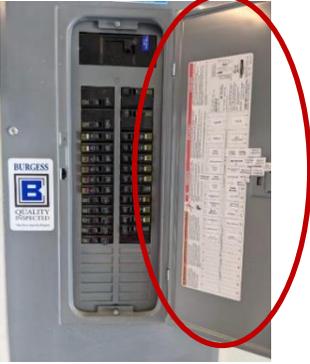
Take a close-up photo of the detail on the main breaker panel so that we can confirm the main breaker rating and manufacturer. If you are intending on upgrading the MSP, please call that out here to our team.

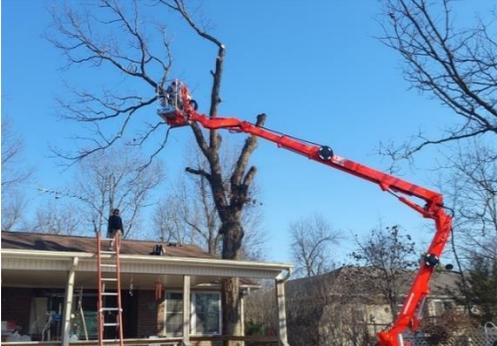
If your team intends on trimming/removing any shading concerns during this project, please provide documentation to provide underwriting with the clear understanding of what work is being performed.
